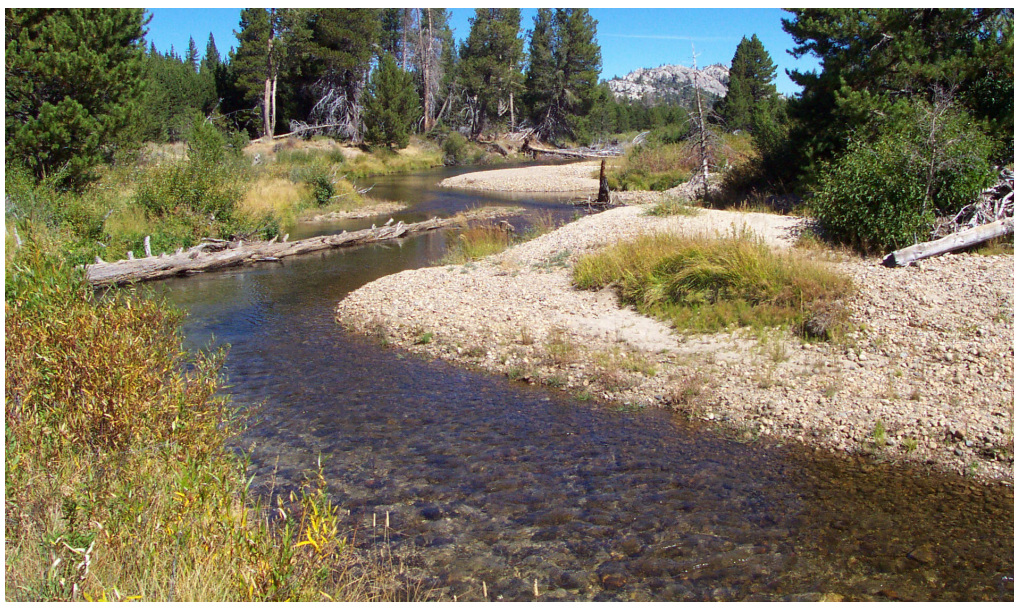
and bank materials are well sorted with sand and gravel predominant in this reach. Near the upper end of the reach bank materials transition to silt and fine sand which appear to be beaver pond deposits. Channel widening is causing undercutting and bank failure of these fine grained banks, however the bank heights, at about 1 m, and the shortness of the reach indicates this area is probably not a great supplier of fine grained material. Overall the fine-sediment availability in this reach is considered to be low due to the coarseness of available material and aggradational nature of the reach.

Figure 4-16. Gravel-bedded aggrading reach composed of well-sorted gravel is rated “low” due to low bank heights, and coarse bed and bank material. Middle of the meandering pool-riffle reach above the golf course.
